**Flood Control Project Maintenance
Levee Inspections**

Fall 2014 Levee Maintenance Deficiency Summary Report

Reclamation District No. 2103 Wheatland Vicinity

Levee Inspection Report By Mile - Fall 2014

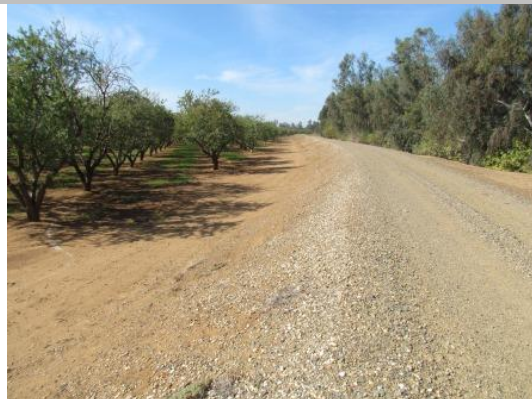
Photo 1 of 1 : FA_2014_RD2103_10_23_20141017_00006.jpg

LM Start	2.26	Rating **	A	Issue No.	23
LM End	2.26	Issue Type +	Ma	Location *	LS
Category	Earthen Levee			GPS Latitude/Longitude	
				Start	End
Item	Vegetation			39.030460 °	39.030460 °
				-121.417276 °	-121.417276 °
DWR ID	DWR_RD2103_01_f_2014_23				
Action/Comments					
Control annual grass and weeds on the levee slopes and easements.

This photo was taken from the crown facing west looking down the landward levee slope at acceptable vegetation maintenance. Fall 2014.

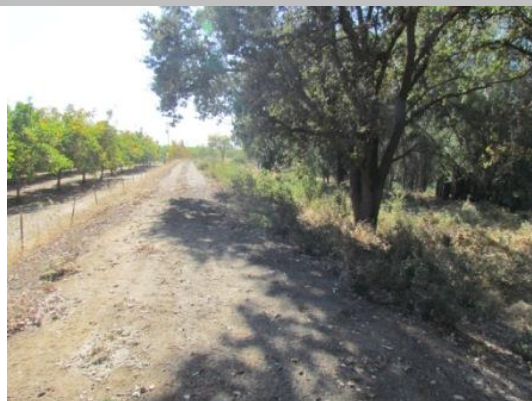
Photo 1 of 1 : FA_2014_RD2103_10_8_20141013_00004.jpg

LM Start	4.52	Rating **	M	Issue No.	8
LM End	4.58	Issue Type +	Ma	Location *	WS
Category	Earthen Levee			GPS Latitude/Longitude	
				Start	End
Item	Vegetation			39.041051 °	39.041810 °
				-121.394931 °	-121.393951 °
DWR ID	DWR_RD2103_01_f_2013_8				
Action/Comments					
Remove the wild growth other than native grasses from the levee slopes.

This photo was taken from the crown of the levee facing west looking at the vegetation on the waterward slope of the levee.

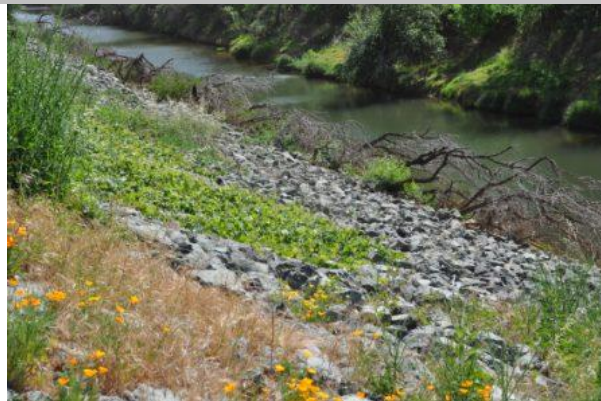
Photo 1 of 2 : FA_2014_RD2103_11_4_20141013_00002.jpg

LM Start	0.30	Rating **	A/W	Issue No.	4
LM End	0.51	Issue Type +	Ma	Location *	WS
Category	Earthen Levee			GPS Latitude/Longitude	
				Start	End
Item	Riprap Revetments			38.994660 °	38.995537 °
				-121.432170 °	-121.428535 °
DWR ID	DWR_RD2103_02_s_2012_4				
Action/Comments					
Inspector Comments: The District has a concern with dead trees placed in the rip rap that may not stay in place during a high water event.

View of revetment with dead trees, Spring 2013.

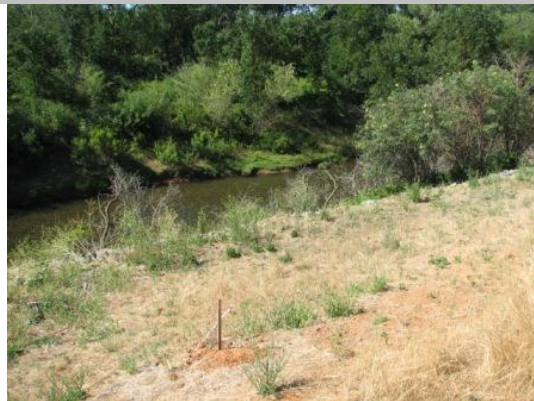
Photo 2 of 2 : FA_2014_RD2103_11_4_20141013_00003.jpg

Trees at waters edge in the rip rap levee mile 0.30.

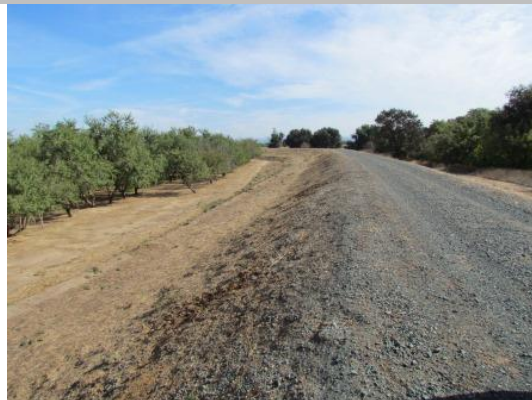
Photo 1 of 1 : FA_2014_RD2103_11_22_20141017_00006.jpg

LM Start	0.74	Rating **	A	Issue No.	22
LM End	0.74	Issue Type +	Ma	Location *	LS
Category	Earthen Levee			GPS Latitude/Longitude	
				Start	End
Item	Vegetation			38.996588 °	38.996588 °
				-121.424209 °	-121.424209 °
DWR ID	DWR_RD2103_02_f_2014_22				
Action/Comments					
Control annual grass and weeds on the levee slopes and easements.

This photo was taken from the crown facing east looking down the landward levee slope at acceptable vegetation maintenance. Fall 2014.
